Inspector General

United States
Department of Defense

Ballistic Testing and Product Quality Surveillance for
the Interceptor Body Armor - Vest Components
Need Improvement

SUBJECT: Ballistic Testing and Product Quality Surveillance for the Interceptor Body
Armor – Vest Components Need Improvement (Report No. D-2011-030)

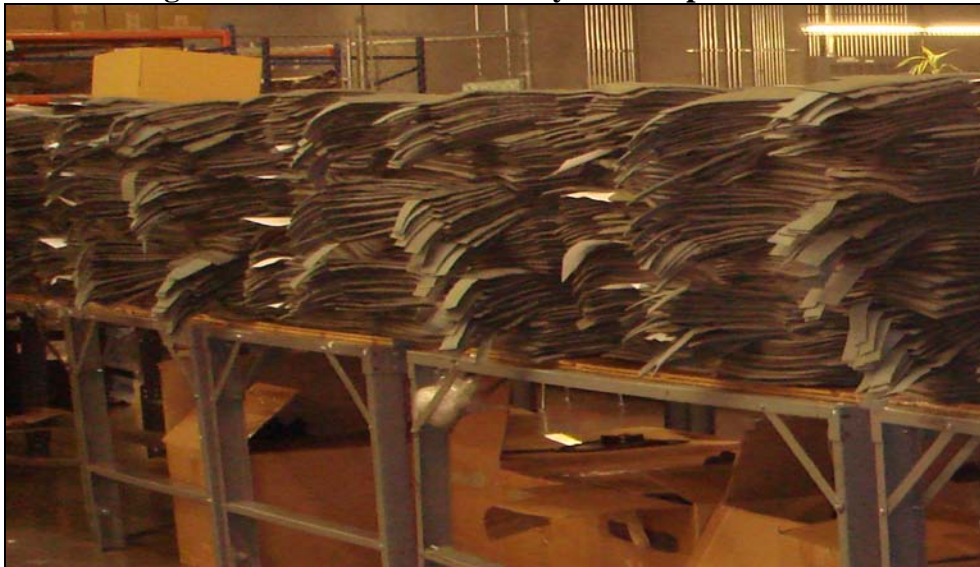
Figure 2. Ballistic Panels Ready for Sample Selection

The LAT sample selection process began with Point Blank personnel notifying DCMA QARs when a lot of ballistic panels was ready for a LAT. An assigned QAR reported to the Point Blank plant and selected samples. Depending on the lot size, the QAR would select three, five, or eight samples; see Finding A, "Lot Acceptance Tests Not Always Required" section for details. Because a vest had more than one ballistic panel, the QAR ensured all applicable panels were pulled for the same serial numbers or samples by placing the panels on a table and comparing the serial numbers. Figure 2 is an example of a ballistic panel lot ready for sample selection.

The QAR selected the samples and recorded the serial numbers on DD Form 1222. The QAR then signed the form and sent it, with the samples, to the applicable laboratory for the LAT. Upon completion of the LAT, the laboratory sent the test results to PM SEQ, DCMA Orlando, and Point Blank.
